Reprinted from  
*Environmental Science & Engineering*, November 2008

# Identification and remediation of a Brownfield property

By Chris Cushing, P.Geo.

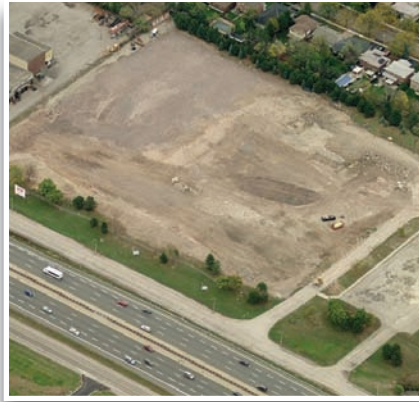
*Aerial view of South Sheridan Way Brownfield to the south-east.*

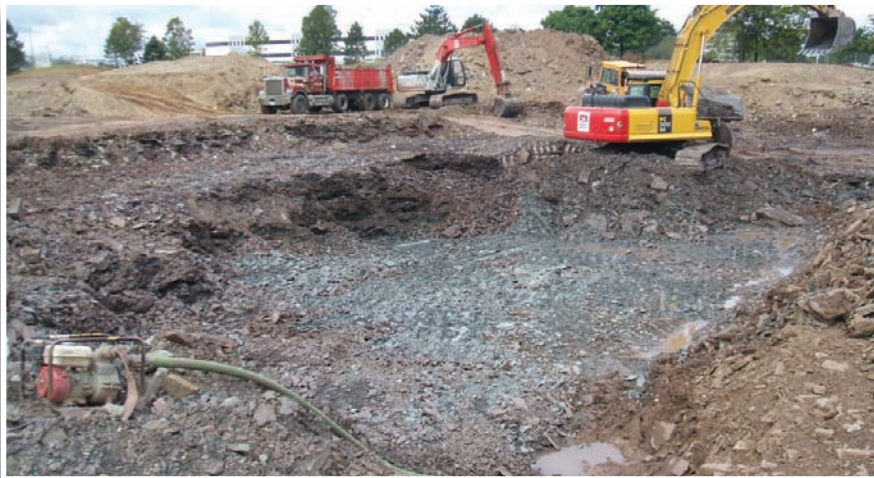
*Phthalate excavation area.*

Soil and groundwater impacted with phthalates were restored using conventional remedial excavation and off-site disposal to available generic Table 3 Site Condition Standards available under O.Reg.153/04. VOC impact to groundwater was addressed through the completion of a human health and ecological Site Specific Risk Assessment (SSRA), coupled with supplemental *in situ* chemical oxidation.

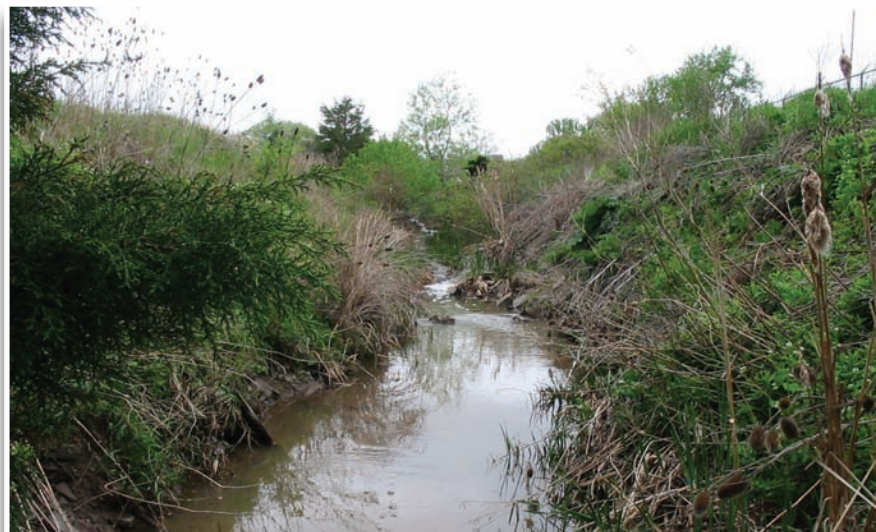
*South end of drainage area.*
